US Army Corps
of Engineers
Construction Engineering
Research Laboratories

USACERL Technical Report FF-94/21
May 1994

Nine-Year Summary of Fort Irwin, CA, Family Housing Comparison Test: Operation and Maintenance Costs of Manufactured vs. Conventionally Built Units

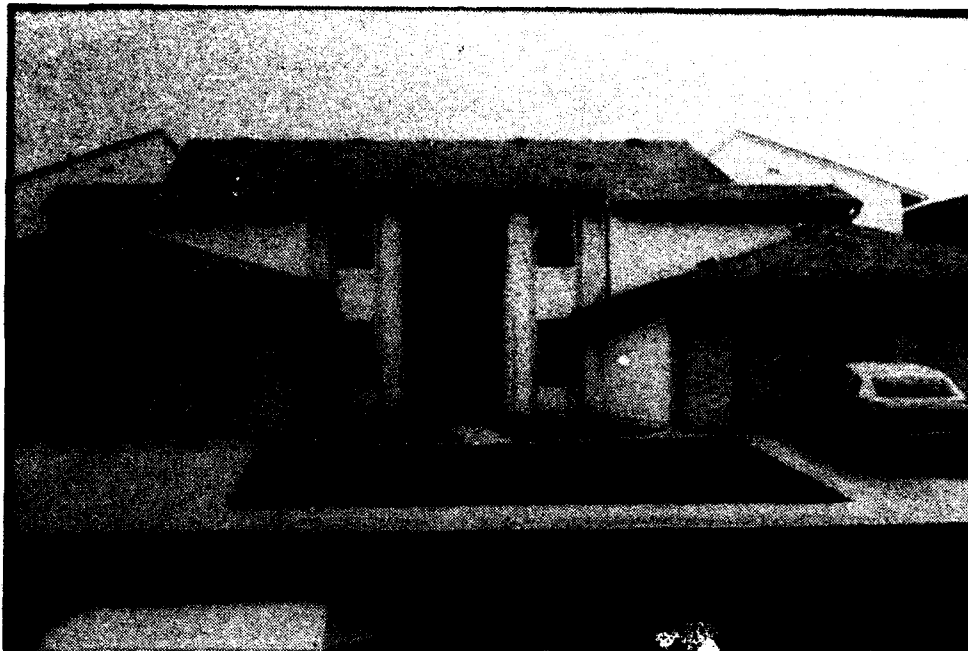
Front View - CBU

Rear View - CBU

Figure 2. Front and rear views of typical CBUs.

The 144 units consist of 13 sixplexes, 6 fiveplexes, and 9 fourplexes, all two-story buildings. Net floor area is 950 sq ft/unit. These units were constructed on perimeter footings with building slab. Each unit has two bedrooms, a kitchen, living-dining area, one bathroom, utility room, either a fenced patio or balcony-porch (for upper unit), and a one-car garage. Figure 2 shows front and rear views of typical buildings. The fourplexes have two units on each level. There are two units on the second story in the five- and sixplexes with the additional unit(s) on the first level. The CBUs also have a refrigerator, gas range, gas water heater, garbage disposal, dishwasher, central air conditioning, and gas-fired forced-air furnace.
